PATHFINDER[®] FOAM CALIPER PIG

Case Study

12" REFINED PRODUCTS PIPELINE, NAPLES ITALY

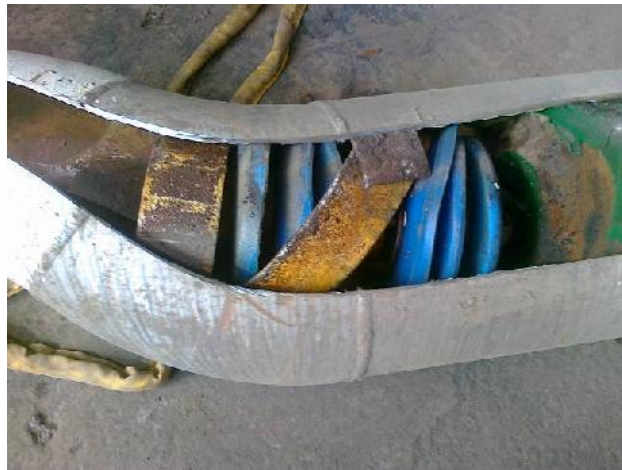
Bi-Di Pig with Dislodged Anodes

The internal anodes are in the form of a circumferential ring, approximately 5mm to 10mm thick and 100mm wide, which are held in place by straps welded onto the inner surface of the pipe. Corrosion appears to have weakened some of the welds on these straps and the force applied by the passage of the pig through the line was enough to rip some of the anodes off the wall.

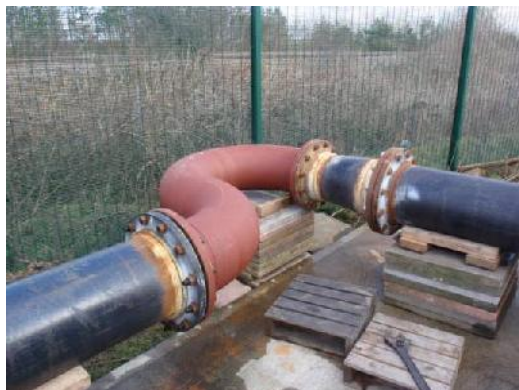
Acceptance testing comprised a witnessed program of further tests in the loop, with the addition of an arrangement of back to back 1.5D bends supplied by the client, and an additional simulated anode positioned on the exit from the bend.

1.5D Back to Back Bends

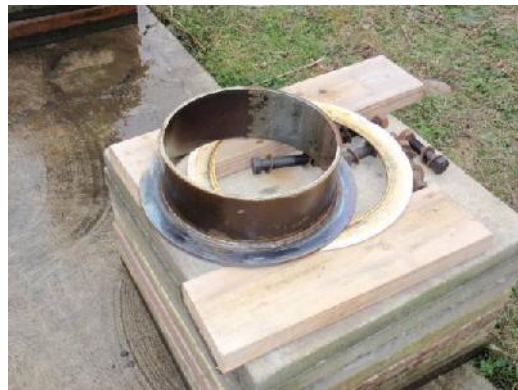
Simulated Anode Ring

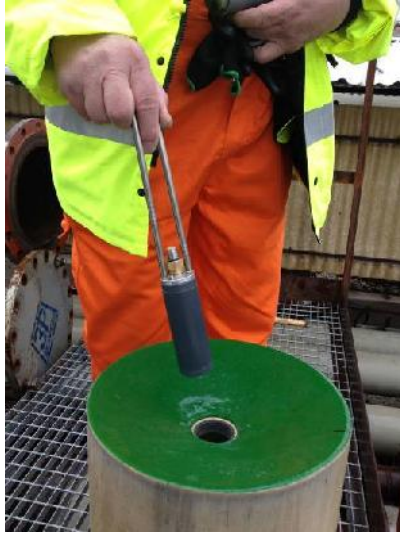
The caliper measurement pod was powered up and inserted into the pig body, followed by an electromagnetic transmitter and the retaining cap.

Caliper Pod

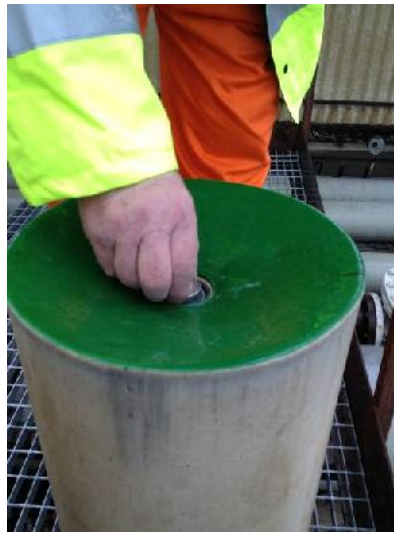
EM Transmitter

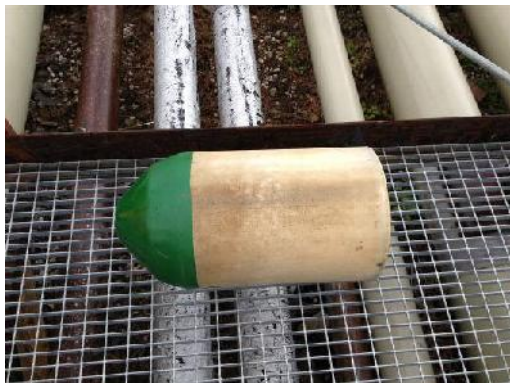
The foam caliper was loaded into a temporary launcher at the terminal end of the pipeline and it was pumped through the line, using water, to the receiver in the tank farm.

Ready for launch

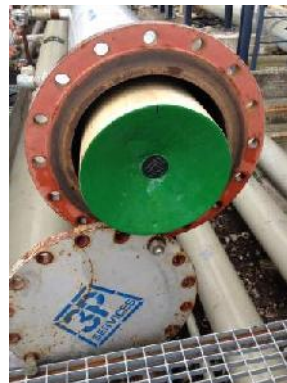
Loading

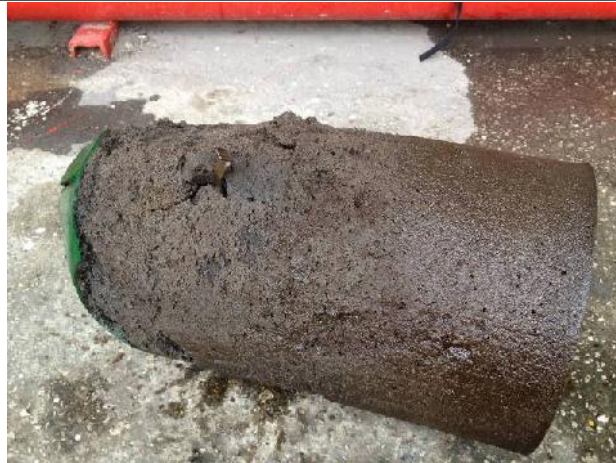
On completion of the run, the front section of the pig was found to have suffered significant damage but the rear section, where the caliper system is located, was in relatively good condition.

Anode Retaining Strap Embedded in Foam Body

- Part of the PU coating on the nose of the pig was missing
- Pieces of foam from the front section of the body had been torn out
- A large tear was present just behind the tapered nose section which extended around most of the circumference and penetrated deep into the structure of the pig body
- An anode retaining strap was embedded in the foam about 100mm behind the tapered nose

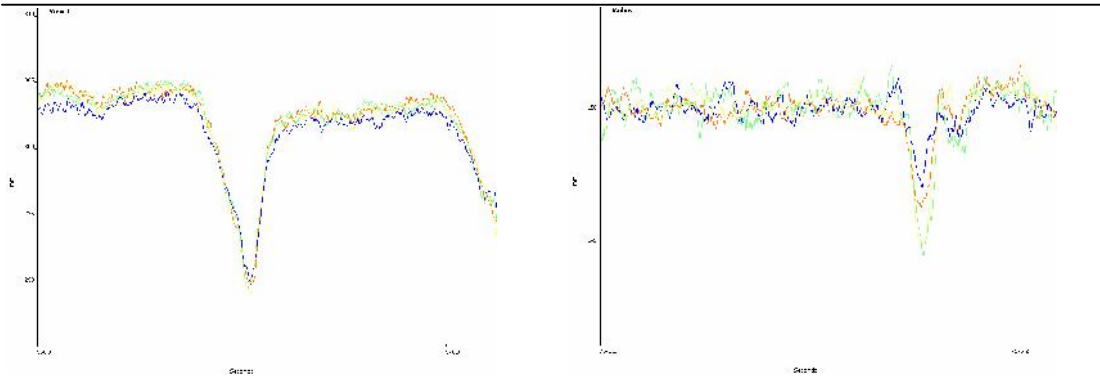
Anode features in the line were identified by comparison with the caliper response to simulated anodes in the test loop at PIL. Examples of the test loop response and the response in the pipeline are shown below:

Test Loop Anode Response

Pipeline Anode Response

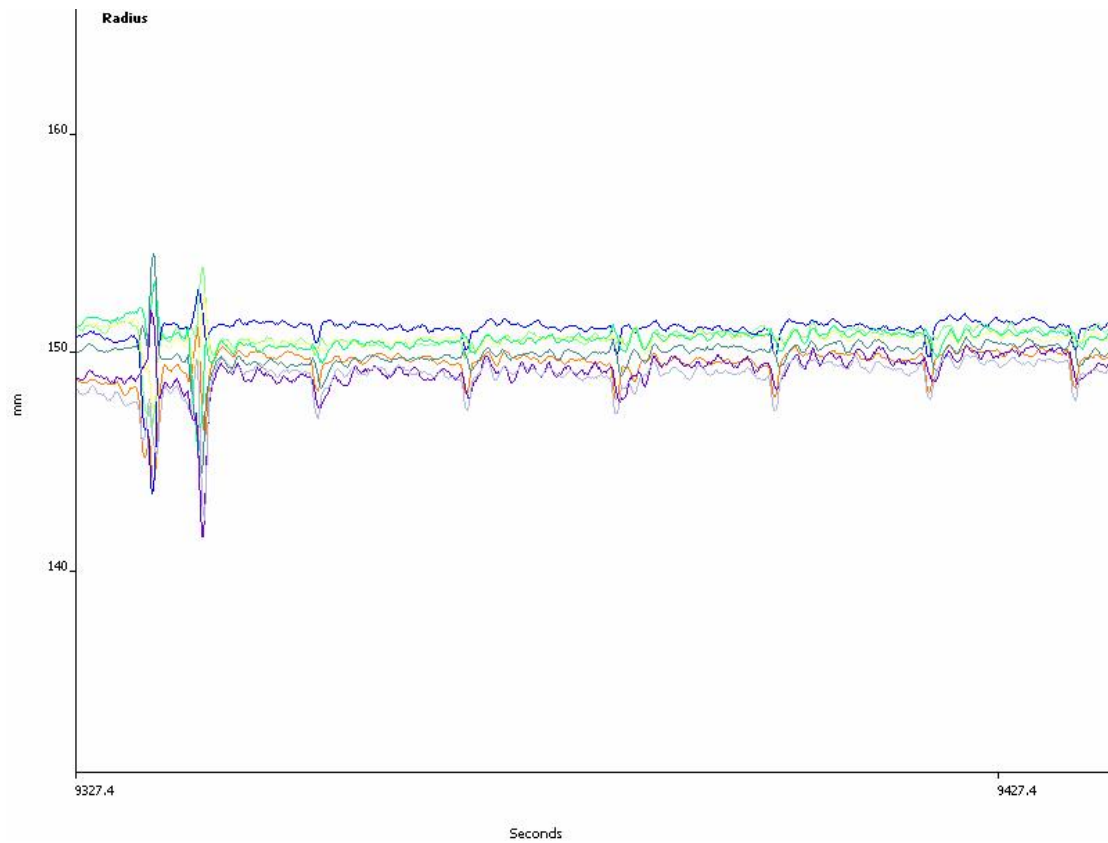
Sample Of Data From Pipeline Showing 2 Bends and 6 Anodes

A total of 144 internal anode features have been positively identified in the data. Using the bend marker data, it has been possible to identify and mark the location of each of the anodes on the strip maps.
